National Park Service Cultural Landscapes Inventory 2002

Catoctin Mountain Park Catoctin Mountain Park

Inventory Unit Summary & Site Plan

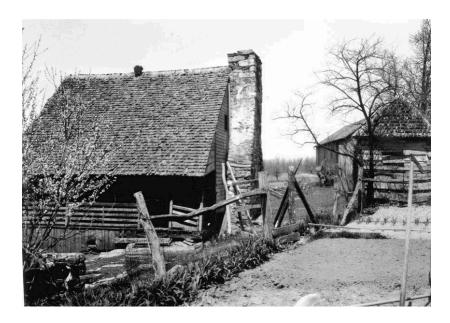
Fig. 10: One of two houses on Ike Smith's farm. Possibly a Chesapeake-style log house, sheathed with clapboard. Note unusual shaped building to right (may be a hexagon), barn in distance and vegetable plot in foreground (c.1937 CMP tract file 93).

a Chesapeake type, with an exterior chimney; confusingly, the Chesapeake type is characteristic of the wider Appalachian region (Noble vol. 1, 1984: 58: also see Fig. 10). The houses were generally one and one-half stories with an attic, and some were two stories. By 1850, if not before, mountain farmers had begun to build German-style bank barns (also called Pennsylvania forebays) (Figures 9 and 11). These substantial structures were framed constructions, usually with vertical board siding. They were "banked" into a slope on mortared-stone foundations, and had a projected forebay on the downhill side. Farmers also continued to use and perhaps even build the more rough-hewn log structures, including such buildings as the single crib or front-drive crib barns (CMP tract files: tracts 18 and 93). By the turn of the twentieth century, the more symmetrical, central hall house, two stories high with an attic, was built on some farms (CMP tract files: tract 18, for example).

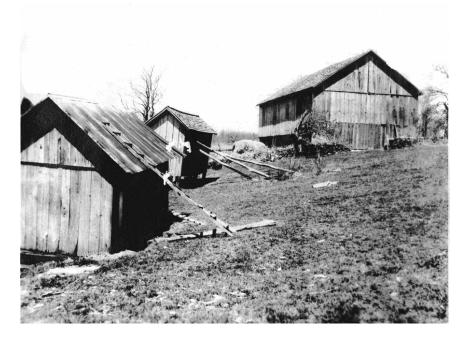
Fig. 11: Ike Smith's farm (tract 93). Slope of this farmyard is typical. Same barn as in previous photo. Note haystack in front of barn and Manahan Road in distance (c. 1937 CMP tract file 93).

There were at least seven bank barns within the boundaries of both the RDA and the later park (CMP tract file photos). These substantial structures were probably as large as 40 by 60 or 30 by 60 feet (Figures 9 and 11). A farm usually included a number of other structures such as log-constructed single-crib barns, sheds for various purposes, wells, perhaps a smokehouse, chicken coops, and privies (Figures 11, 15 and 16). At least one had an ice house (CMP tract files: tract 53). Of the more substantial farms, one had 12 outbuildings, plus a barn and dwelling and another had nine outbuildings, plus two dwellings and a barn (CMP vertical files: CH-044; CMP tract files: tracts 55 and 93). Fences of different types and drylaid stone walls completed the farmstead arrangement (Figures 13 and 14). Fence types included the stake and rider (a kind of worm fence), post and rail, rustic picket, and wire mesh attached to posts (Figure 14).

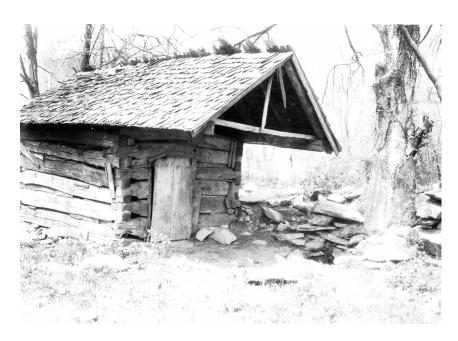
Fig. 15: Small front-drive crib barn on tract 94, probably one of original farm buildings, constructed of notched hand-hewn logs. Treatment of shingle roof along ridgeline is typical of many buildings seen in tract photos (c. 1937 CMP tract file 94).

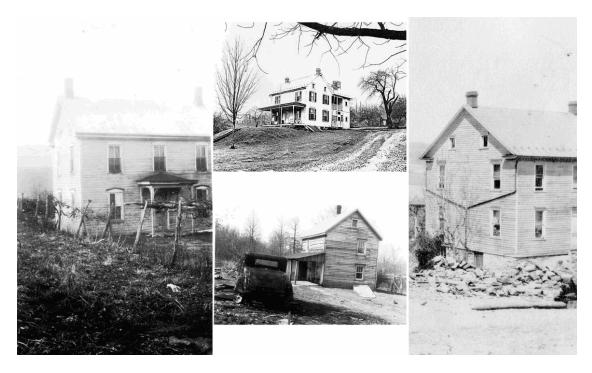
Fig. 12: Some houses within boundaries of park were modest central-hall types. Center at bottom is a log house under partial clapboard siding. Left: tract 87; top middle, unknown; bottom middle, tract 92; and right, tract 18 (c. 1937 CMP tract files).

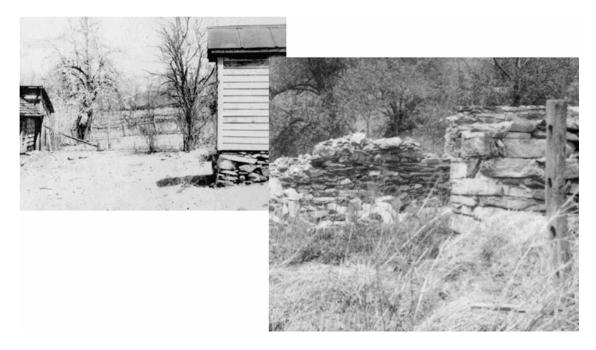
Fig. 13: Examples of stone foundations and piers. Stone wall at right (tract 94) is from destroyed barn, judging by its straightness and height. It is mortared, unlike stonework under small building on left (tract 18) (c. 1937, CMP tract files).

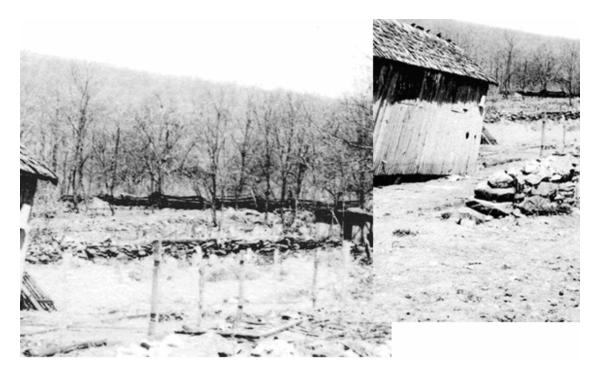
Fig. 14: Different sections of same photo to show examples of stone walls and fences that divided areas of farms in Catoctin. Zig-zag rail fence in back is called a stake and rider fence. (Both c. 1937, CMP tract file 18.)

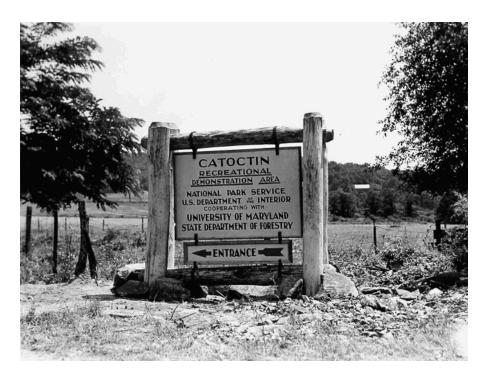
Fig. 17: Sign for Catoctin Recreational Demonstration Area circa 1940, probaby along Manahan Road, pointing to Central Garage Unit and headquarters at today's Round Meadow (CPP-027, CMP vertical files).

The most visible small scale features today are such items as park signs, waysides, and picnic tables, none of which date to the period of significance. The original Catoctin RDA sign near the project headquarters at Foxville (Figure 17) was hung from posts, 10 or 12 inches in diameter. There was also a sign at the Blue Blazes entrance that gave the distance to the three group camps and project headquarters. New signs were necessitated when the area was renamed Catoctin Mountain Park in 1954. During the mid- and late-1960s, the Job Corps constructed a number of park signs. The present entrance sign is more recent. None of the signage is contributing.

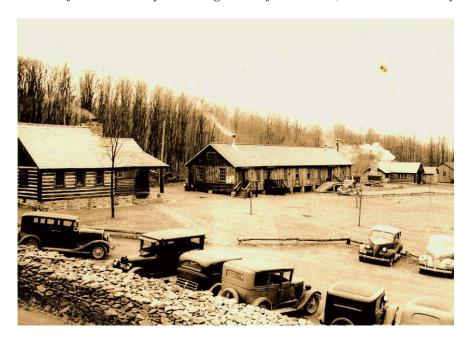
Fig. 21: Central Garage Area and headquarters circa 1940. Building on left is resources office today; middle building was tool house torn down in 1964; blacksmith shop on right. The stone wall was reconstructed by the CCC (CPP-004A, CMP vertical files).

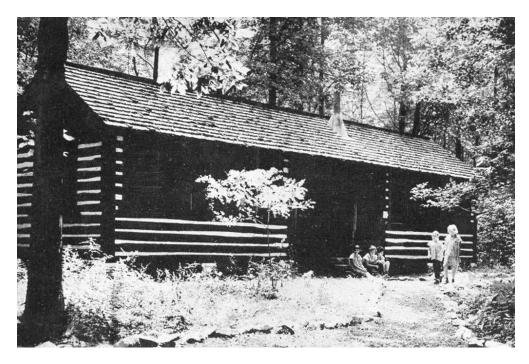
Fig. 22: Campers' cabins at Greentop, such as this one, were larger to accommodate children and leaders together. Trail here is part of one that unified camp. Note gravel and stone edging (c. 1950, CPP-020-16, CMP vertical files).

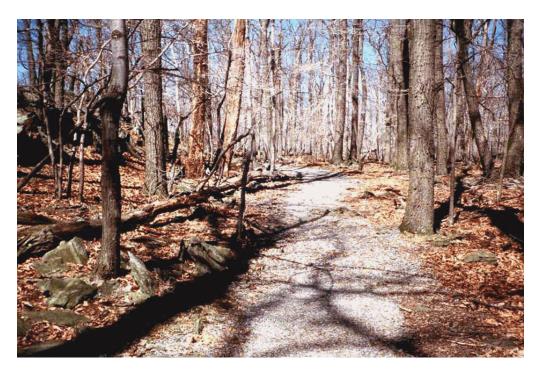
Fig. 23: Gravel-strewn path on central plateau, enroute to Blue Ridge Summit overlook (1999).

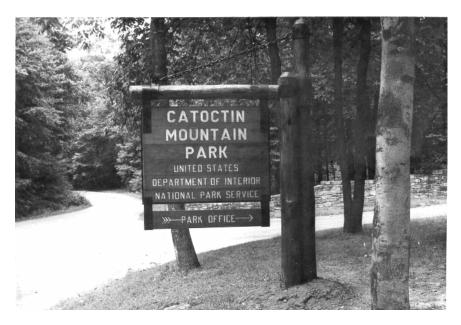
Fig. 24: Sign at park entrance circa 1956. Photo shows old alignment of Route 77 by Visitor Center and CCC-built stone wall in background (CPP CMP vertical files).

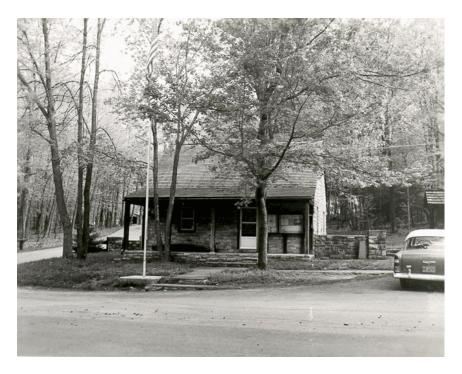
Fig. 25: Contact station before it was enlarged in 1965 to become the Visitor Center (c. 1960, CPP-027-19 CMP vertical files).

Mission 66 witnessed the introduction of some new use areas and the expansion of others. Roads were paved, adapting them to mid- and late-twentieth century use, and subtly changing the park from its 1940s appearance. The contact station became the Visitor Center and tripled its footprint. The road in front of it was realigned. Trails were added and changed in places. Development that might have occurred on the north side of the central plateau did not because of the President's Retreat. Physical changes have often reflected shifting issues. During the 1970s, folk life themes were predominant. Although new buildings were contemplated for that program, none were built. The Job Corps Center left a more lasting impact at Round Meadow. In recent years, issues of accessibility have affected paths and entrances to buildings.

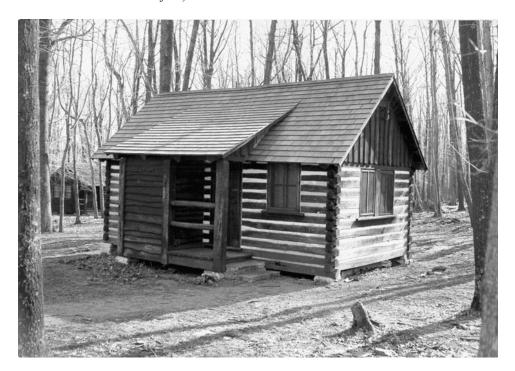
Fig. 26: Staff cabin at Greentop with new roof, part of Mission 66 work on park structures (c. 1967, CPP CMP vertical files).

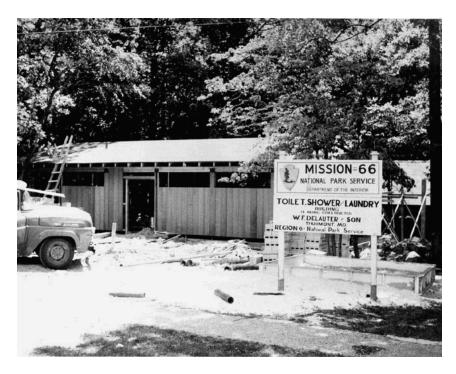
Fig. 27: During the Mission 66 years the original shower and laundry buildings at the cabin camps, called washhouses, were replaced with new ones. This construction work is at Greentop (c. 1962, CPP-077-23 CMP vertical files).

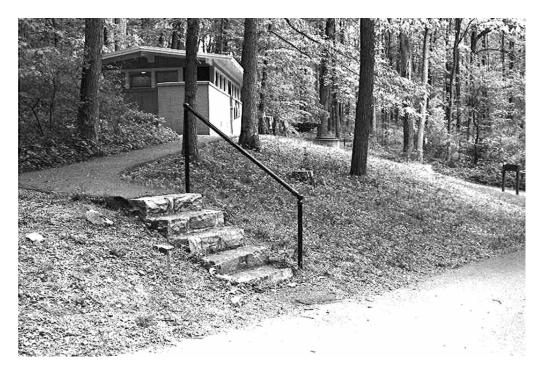
Fig. 28: Stone steps and iron handrail leading to comfort station at Owens Creek Campground, constructed in 1965 (1999).

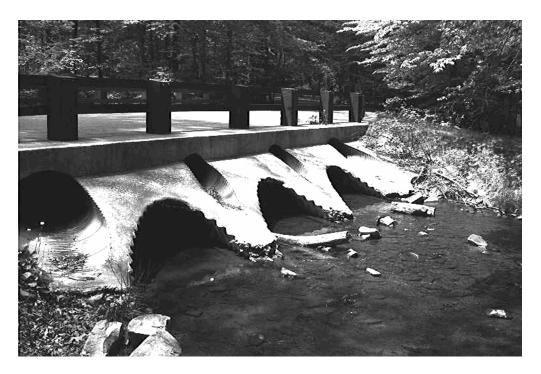
Fig. 29: Metal arch culvert bridge leading to Owens Creek campground. Two previous metal arch bridges, the first built in the mid-1960s, with grouted rubble rather than concrete headwalls, have washed out. This version probably dates to 1990s (1999).

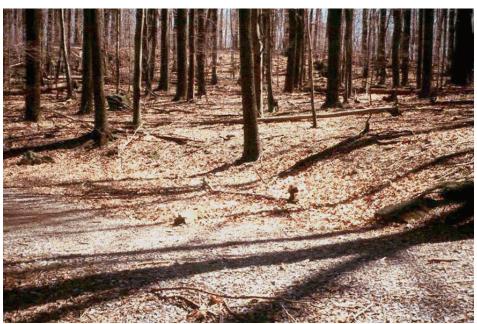
Fig. 54: Path crosses old charcoal hearth (sloped sides are evidence) on trail to Blue Ridge Summit overlook (1999).

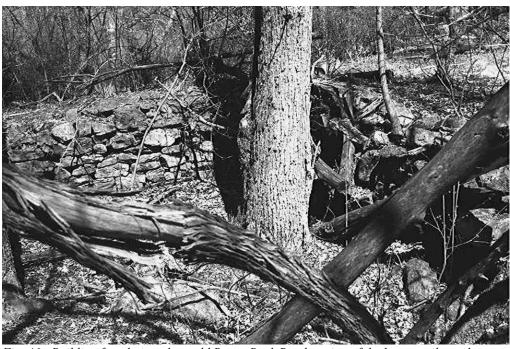
Fig. 46: Building foundation along old Raven Rock Road section of the horse trail, northwest area of park (1999).

1. The structural integrity of the nineteenth-century foundations and stone walls is being

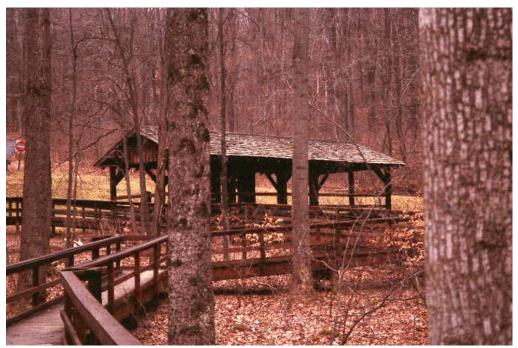
Fig. 48: Reproduced nineteenth-century vertical sawmill built in the 1970s. Accessibility walkway is more recent (1999).

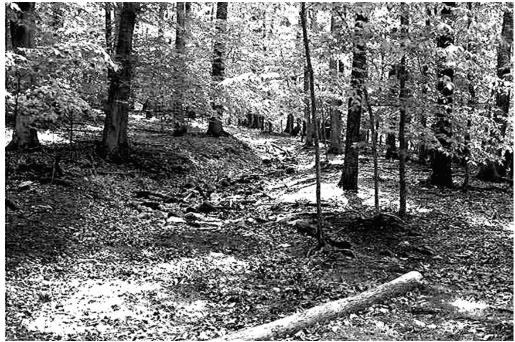
Fig. 45: Narrow and deep-cut road trace near Owens Creek campground filled in with rocks (1999).

- 2. Where possible, the original path system should be preserved and repaired with similar materials. Where changes must be made, all details should reflect the historic character of the features.
- 3. The effects of deer browse, and pest infestation should be closely monitored.

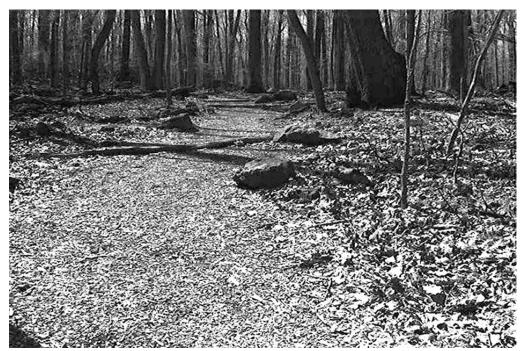
Fig. 52: General character of Hog Rock Trail. Stones are moved to the side of the trail and form a naturalistic, irregular edging. Water bars were probably added in the 1970s. (1999)

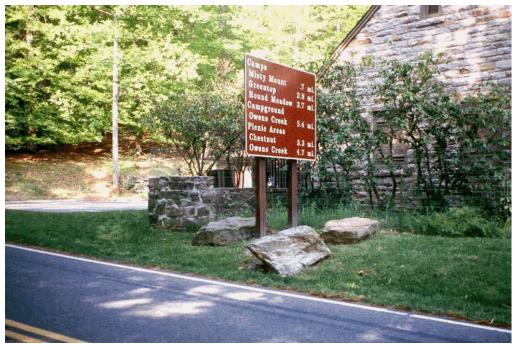
Fig. 53: Sign by Visitor Center on Park Central Road gives distances to locations along road. Stone wall behind sign is a section of the original park gate, possibly altered (2000).

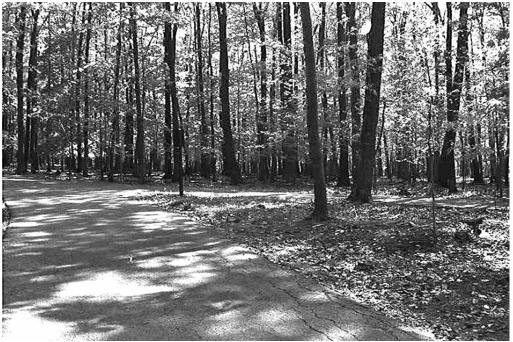
Deer browse line is seen in cropped vegetation up to an approximate four or five foot height. This is at Chestnut Picnic Area (1999).

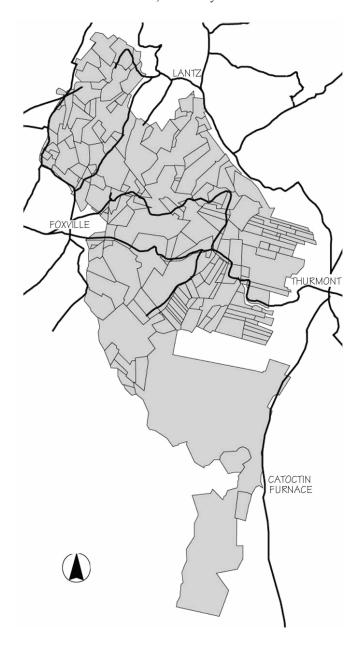
Description: Property Map prepared in 1937 for the Catoctin RDA shows 133 individual

properties, nearly all of which were eventually purchased. Route 77, the road between Thurmont and Foxville, divides the RDA into Catoctin Mountain Park on the north and Cunningham Falls State Park on the south. Various patterns can be discerned in the tracts, such as the 3000-acre remainder of the furnace land at the bottom, the evenly-drawn tracts on the east side, and the irregular ones on the west.
